Manhole Inspection Summary

Manhole # S11WW_013MH

Insp Date: **7/30/07 12:53 PM**

Location Address: **3417 DORCHESTER RD** Cross Street: **DENNLIN AVE**

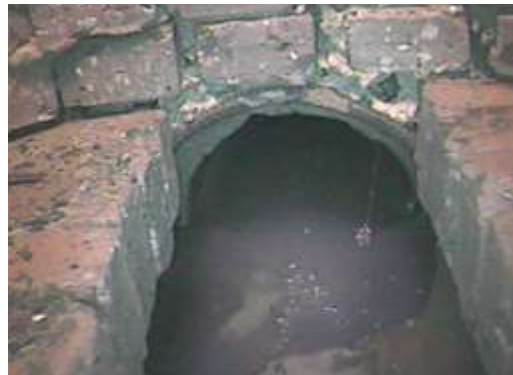
Defect 1

Condition: ☐ Sound ☒ **Cracked** ☐ Root Intrusion ☐ Deteriorated ☐ Leaks ☐ Debris

BROKEN CLAY/CRACK IN CHANNEL

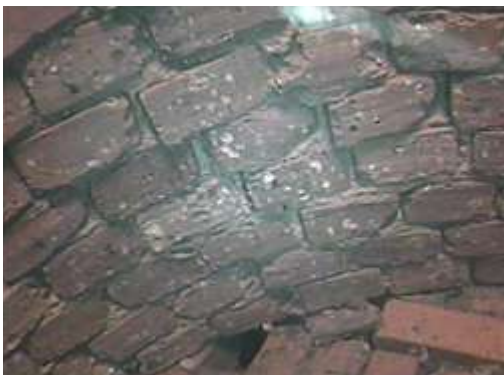
Defect 2

Condition: ☐ Sound ☐ Cracked ☐ Root Intrusion ☒ **Deteriorated** ☐ Leaks ☒ **Debris**

LOOSE BRICKS AND DETERIORATION
ON BENCH

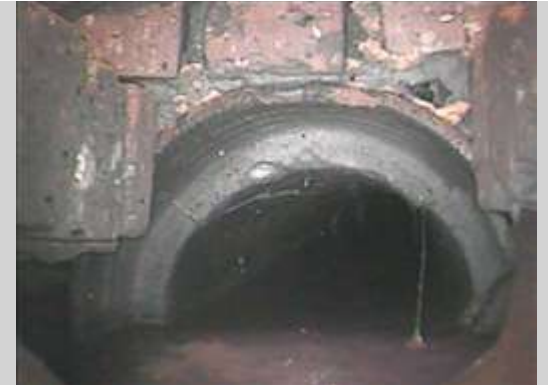
12 O'Clock Outflow

Infiltration: **None** Pipe Seal Cond: **Broken**
